PHASE I ENVIRONMENTAL SITE ASSESSMENT

HARDESTY FEDERAL CENTER
607 HARDESTY AVENUE
KANSAS CITY, MISSOURI

Terracon Project No. 50997737
August 19, 1999

UNITED STATES GENERAL SERVICES ADMINISTRATION
Kansas City, Missouri

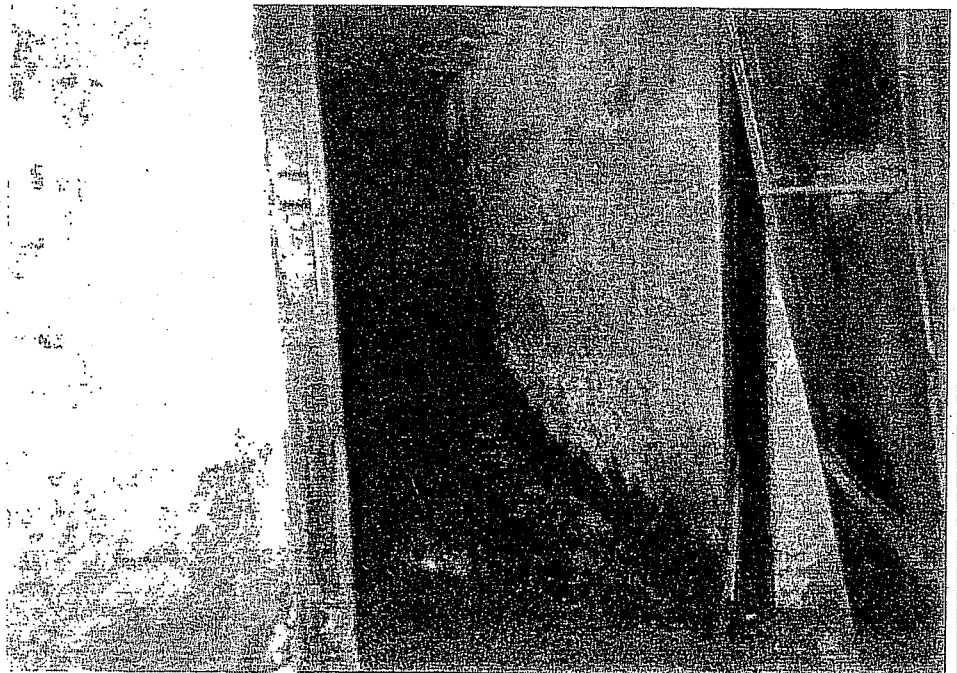
Photo #5

Description: Boilers in
Building No. 3.
